# The council starts the geophysical study of the subsoil in El Confital

The municipality of Las Palmas de Gran Canaria continues the planned work plan to locate the source of the contamination by enterococci that caused the closure of El Confital Beach between April 26 and June 16 last. Ciudad de Mar expects for the next few days this week the results of the first phase of the geophysical study, through electrical tomography, carried out by the company Geophysical Insular Applications in the sand of this beach in the capital. The bathing water of the beach presents levels within the normality.

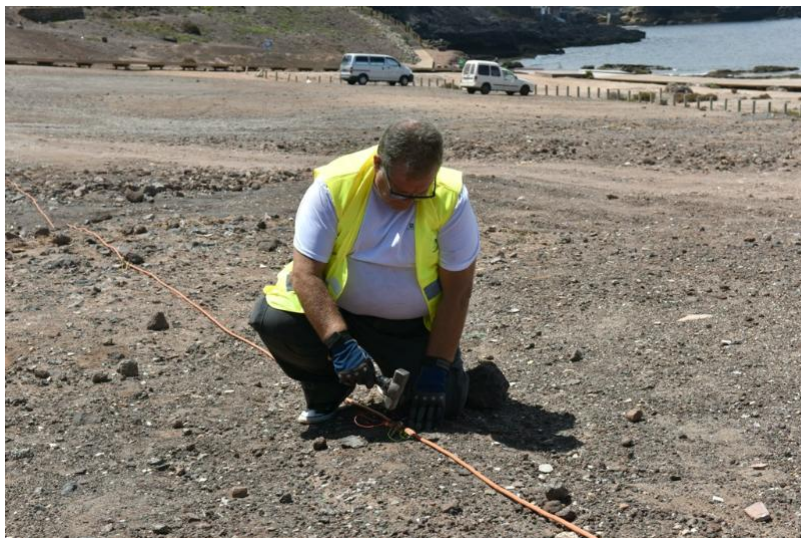
In red, zones of profiles of resistivities realized in El Confital

Island Geophysical Applications carried out this first phase of the study last Thursday, June 29, with three profiles of Electrical Tomography in three distinct areas of the beach in an extension of 275, 260 and 230 linear meters.
